REPORT NO. 100025203CHI-001

RENDERED TO:
EcoFit Lighting LLC
8527 Bluejacket
Lenexa, KS 66214

Test Criteria: The evaluation was a Corrosion Testing of the DuraStreet Light Assembly from EcoFit Lighting LLC.

Standards Used: ASTM B117 Standard Practice for Operating Salt Spray (Fog) Apparatus – Corrosion Testing

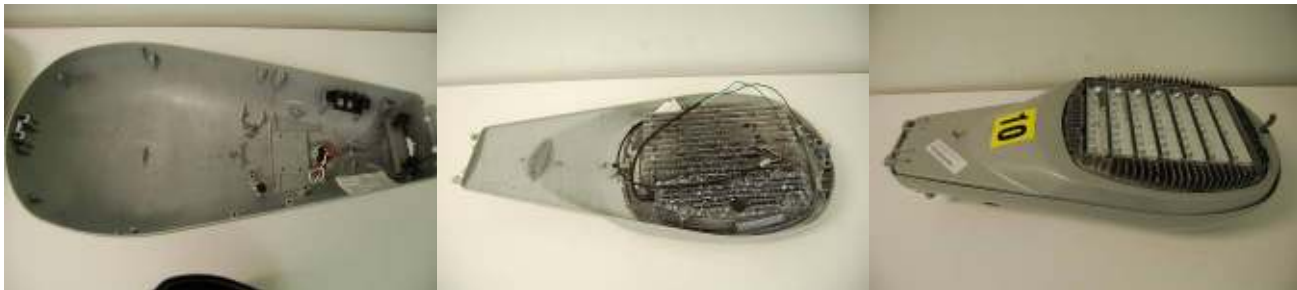
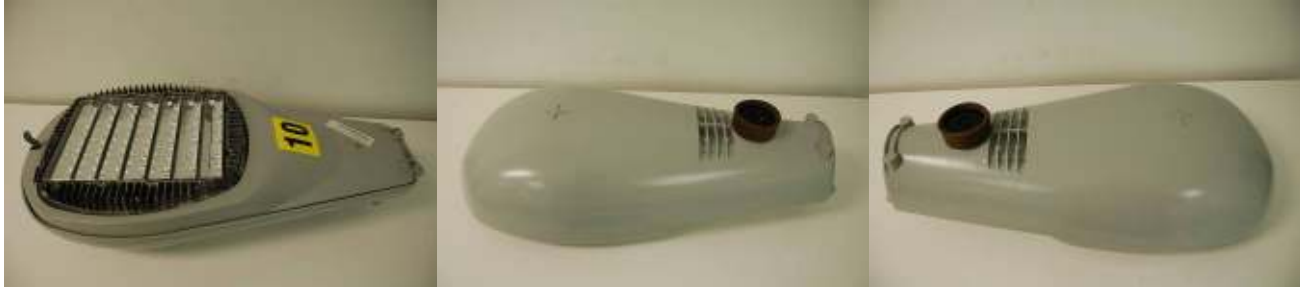
Photos:**After 48 Hour 5% Salt Spray Exposure:**

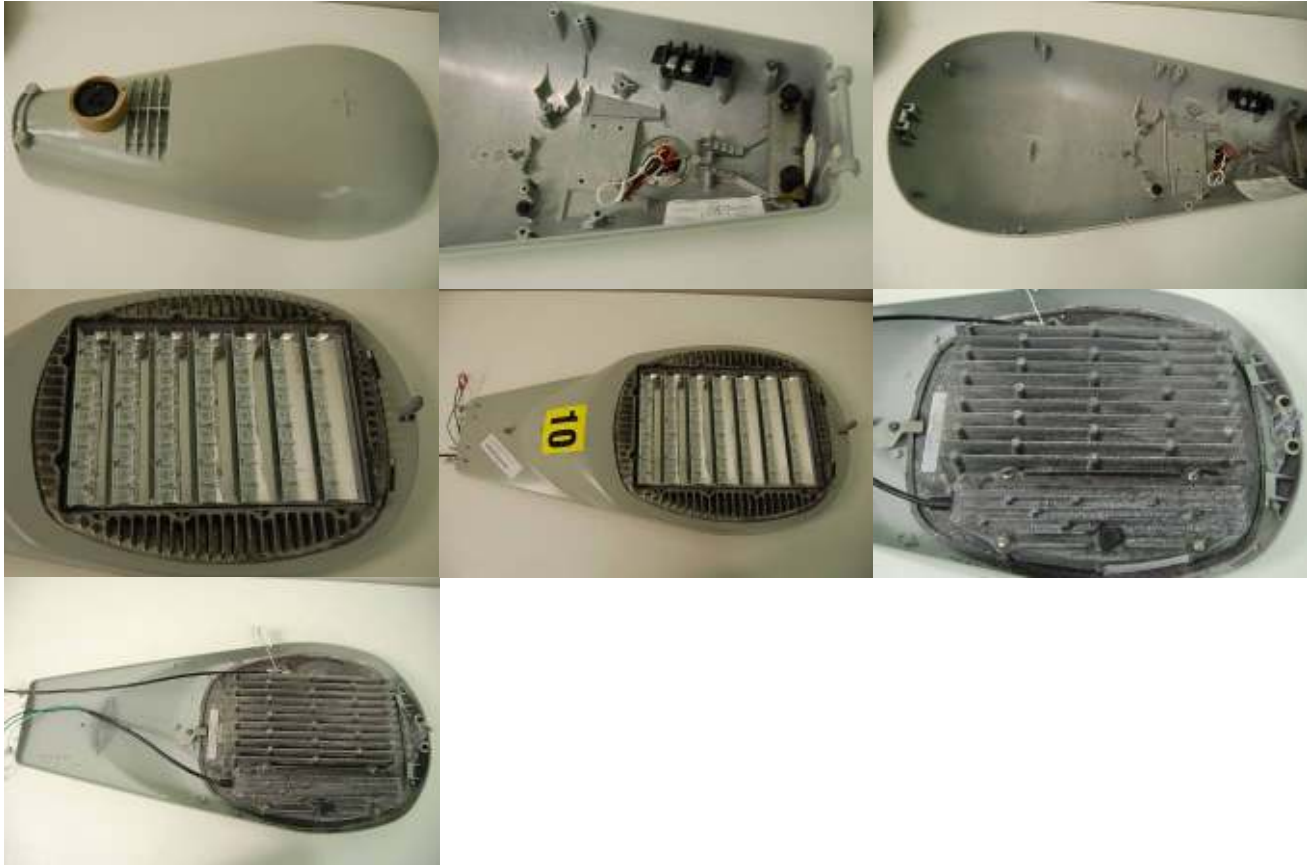
After a 48 hour, 5% salt spray (fog) exposure and 48 hour dry time there was no significant corrosion on any surfaces of the received product sample. There was oxidization on the aluminum surfaces which was easily removed. Minor corrosion formed on the clamp inside the product that holds the light ballast in place. This corrosion did not cause a loss of function.

After 48 Hour Drying Period:

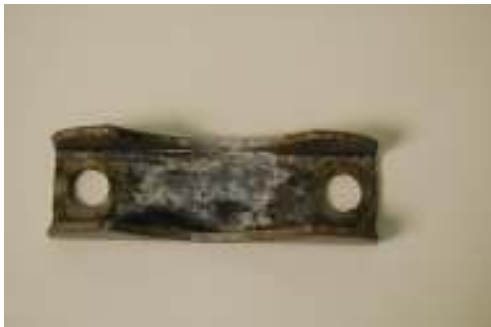
Minor Corrosion on Clamp:
